# Manhole Inspection Summary

Manhole # S43E\_\_011MH

Insp Date: **6/9/08 11:40 AM**

**Location** Address: **30 n bond st**

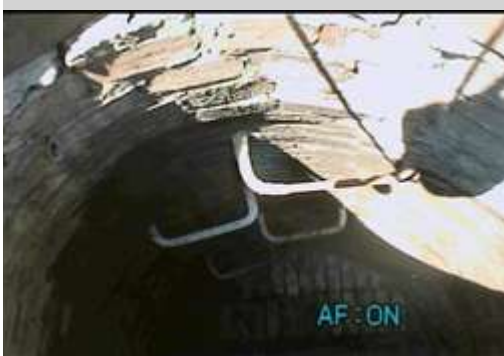
Defect 3

**Steps** Count: **4** Missing: **0** ☒ **Corroded**

corroded steps

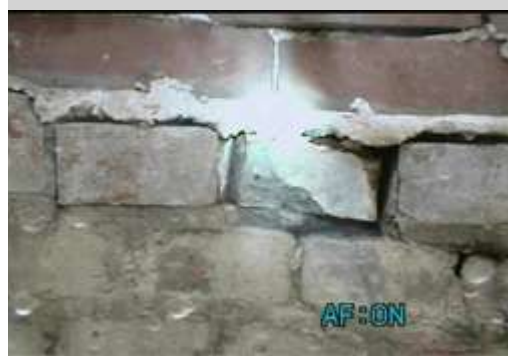
Defect 2

Condition: ☐ Sound ☐ Cracked ☐ Root Intrusion ☒ **Loose Brick** ☐ Deteriorated

corbel loose bricks

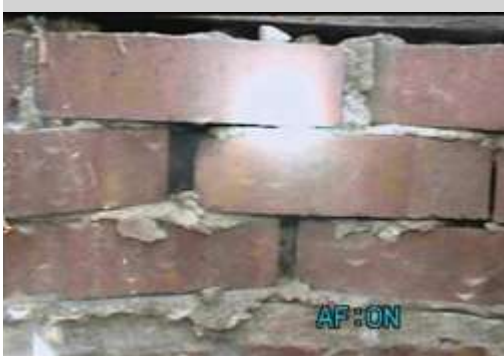
Defect 1

Condition: ☐ Sound ☐ Cracked ☐ Root Intrusion ☒ **Loose Brick** ☐ Deteriorated

Chimney loose bricks,  
frame adj

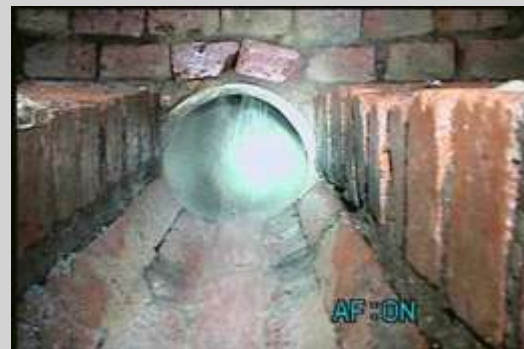
Drop In @ 6 OClock

Drop: Outside Direct

Drop Condition: Partly Clogged
